Orness Plaza: Integrating Health & Sustainability

Charrette to Grand Opening and Beyond– Integrated Design for Health and Environmental Improvement in Green Buildings—The Orness Plaza Study

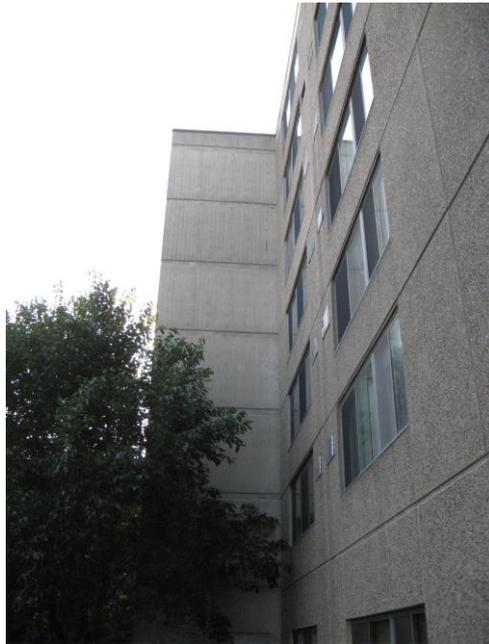
Envelop options

remove replace existing concrete

1. insulated panel;
2. un-insulated panel with insulation on the interior

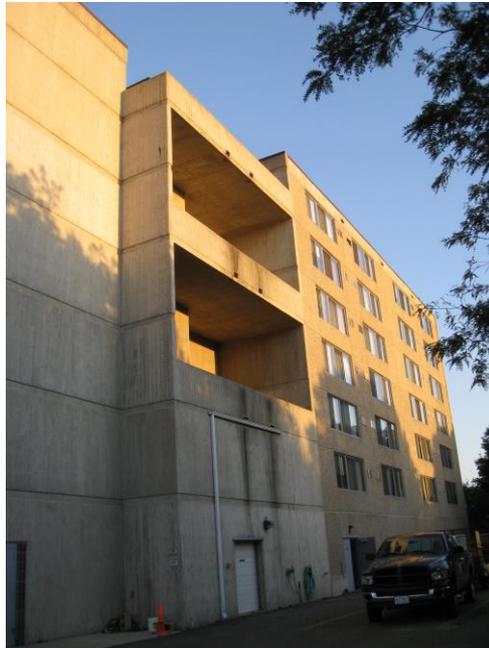
retrofit existing exterior without removal of concrete panels

1. EFIS over existing
2. metal pan finish over existing

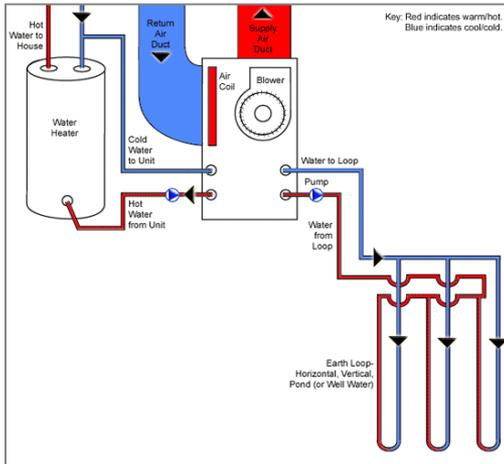
Mechanical systems options

heating/cooling

1. geothermal full system

2. conventional system

3. hybrid - piggyback geothermal on to existing system

ventilation

1. exhaust only

2. supply/exhaust

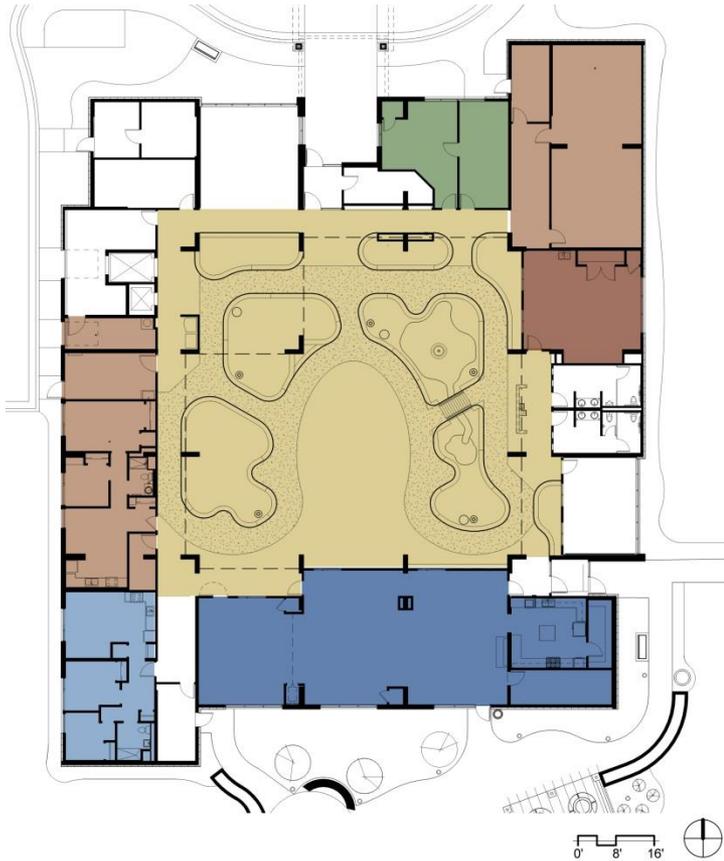
First Floor Plan

First Floor

Atrium
-

Community Room
-

Game Room
-

Office
-

Mechanical/Maintenance
-

Unit

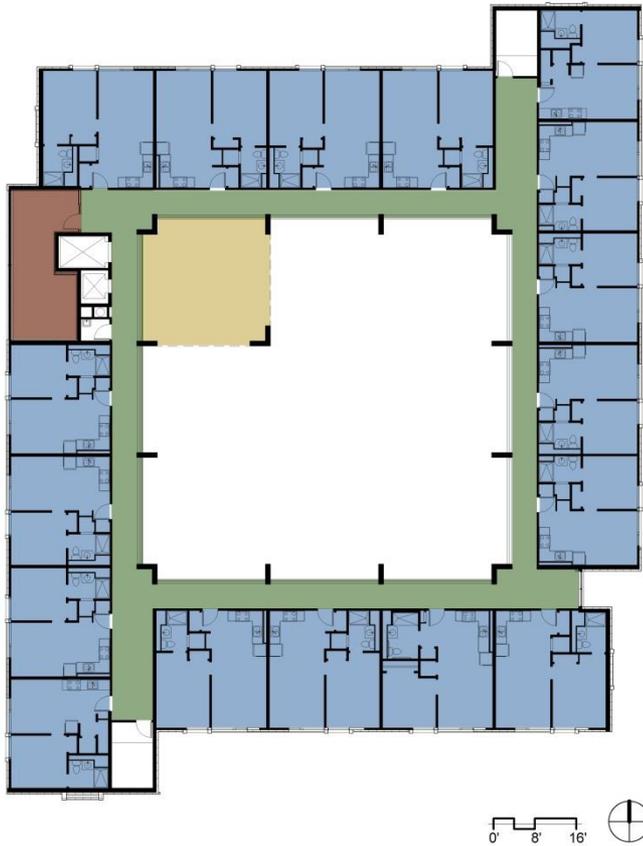
Upper Level Plans

Upper Levels

Atrium
-

Community Room
-

Units
-

Corridors
-

Exterior Balconies
-

Interior Balconies

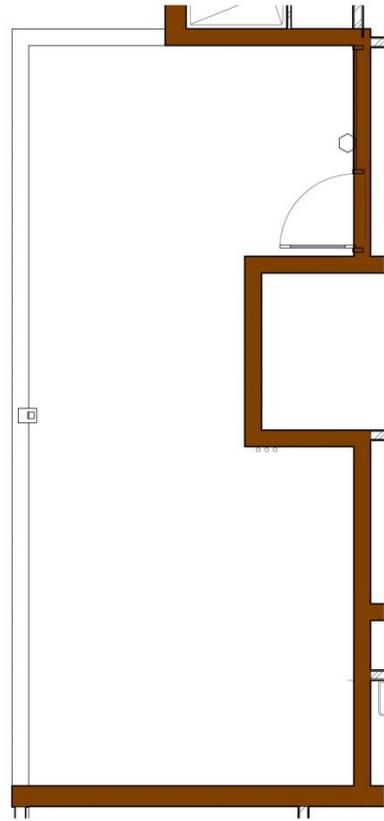
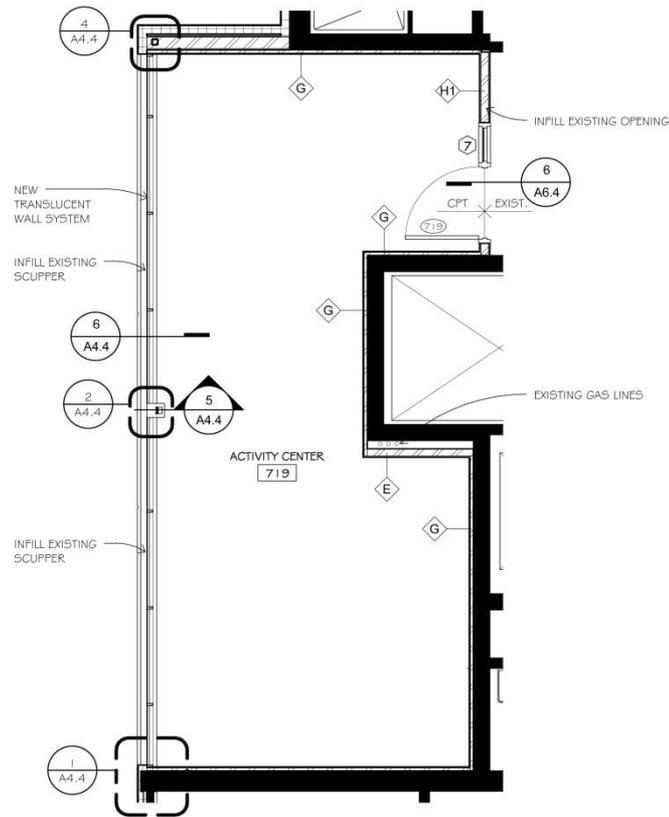
Balconies

Before

After

- Simplify the envelope
- Year-round usable space

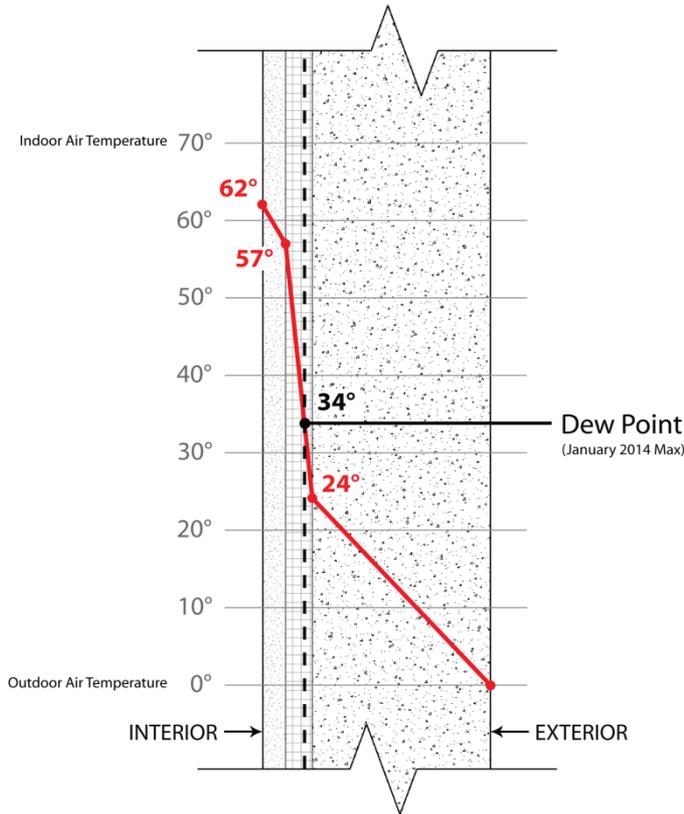
ORIGINAL WALL CONSTRUCTION

Typical Wall Section

Approx. R-5 insulation value

Nearly a 400% increase in thermal resistance!

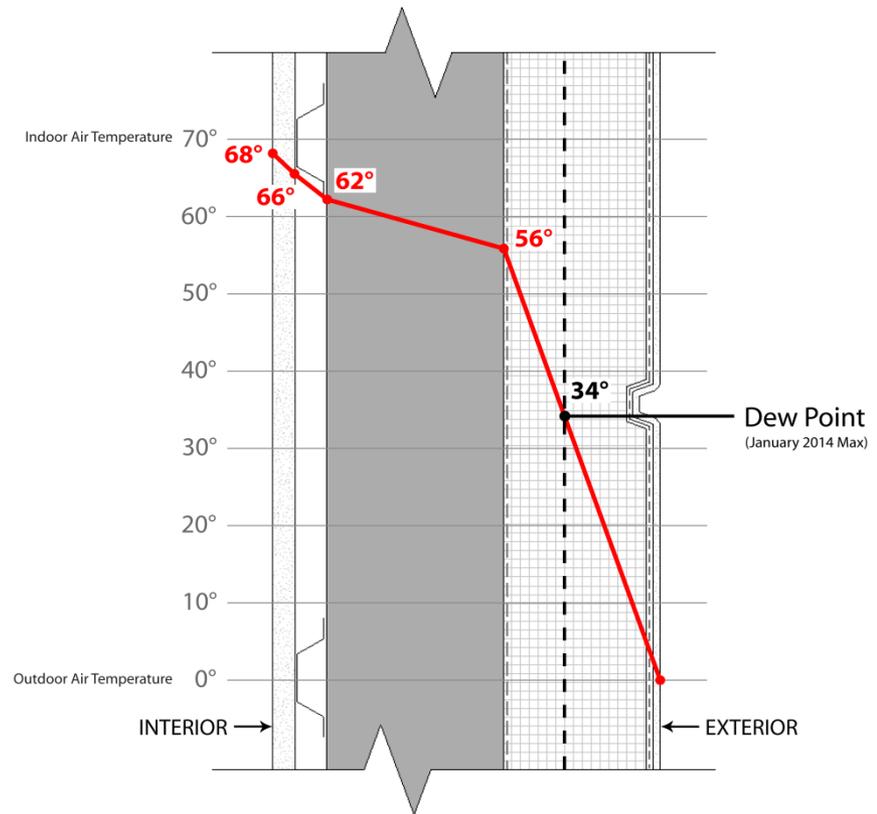
NEW WALL CONSTRUCTION

Approx. R-19 insulation value

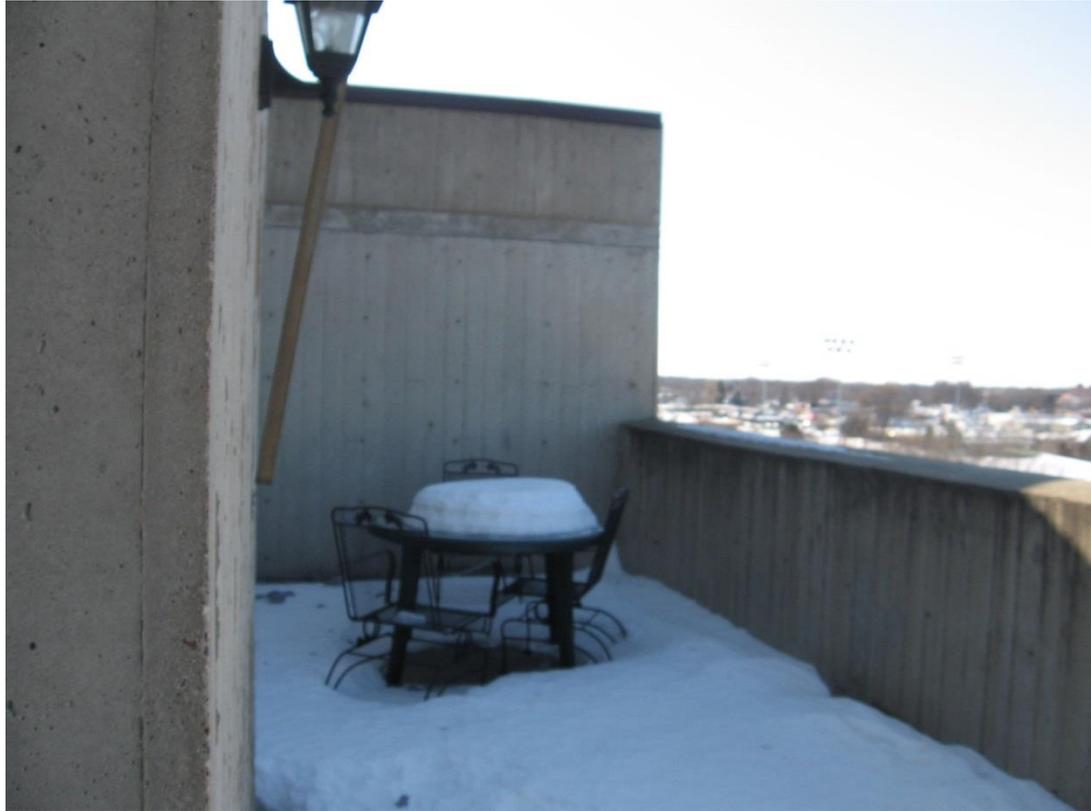
Building Commons – Balconies Before Construction

- Three balconies
- Exterior exposure
- 7th floor open to sky
- Unused during cooler months
- Uninviting

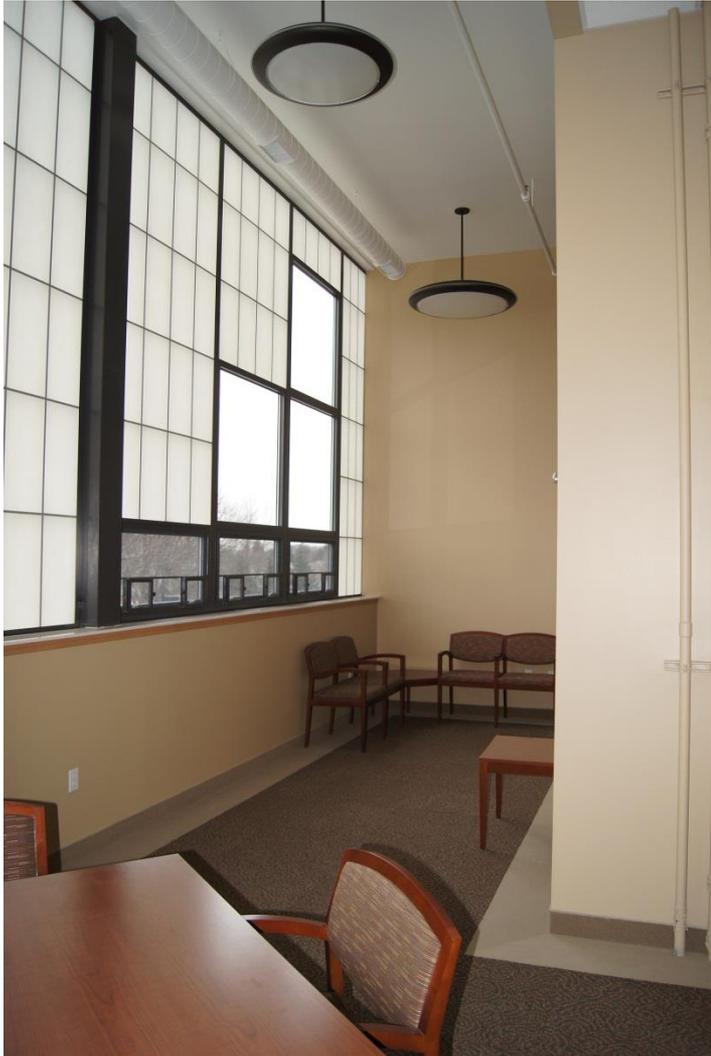
Building Commons – Balconies During & After Construction

- Added roof at 7th floor
- Enclosed all spaces
- Included filtered light, but with views

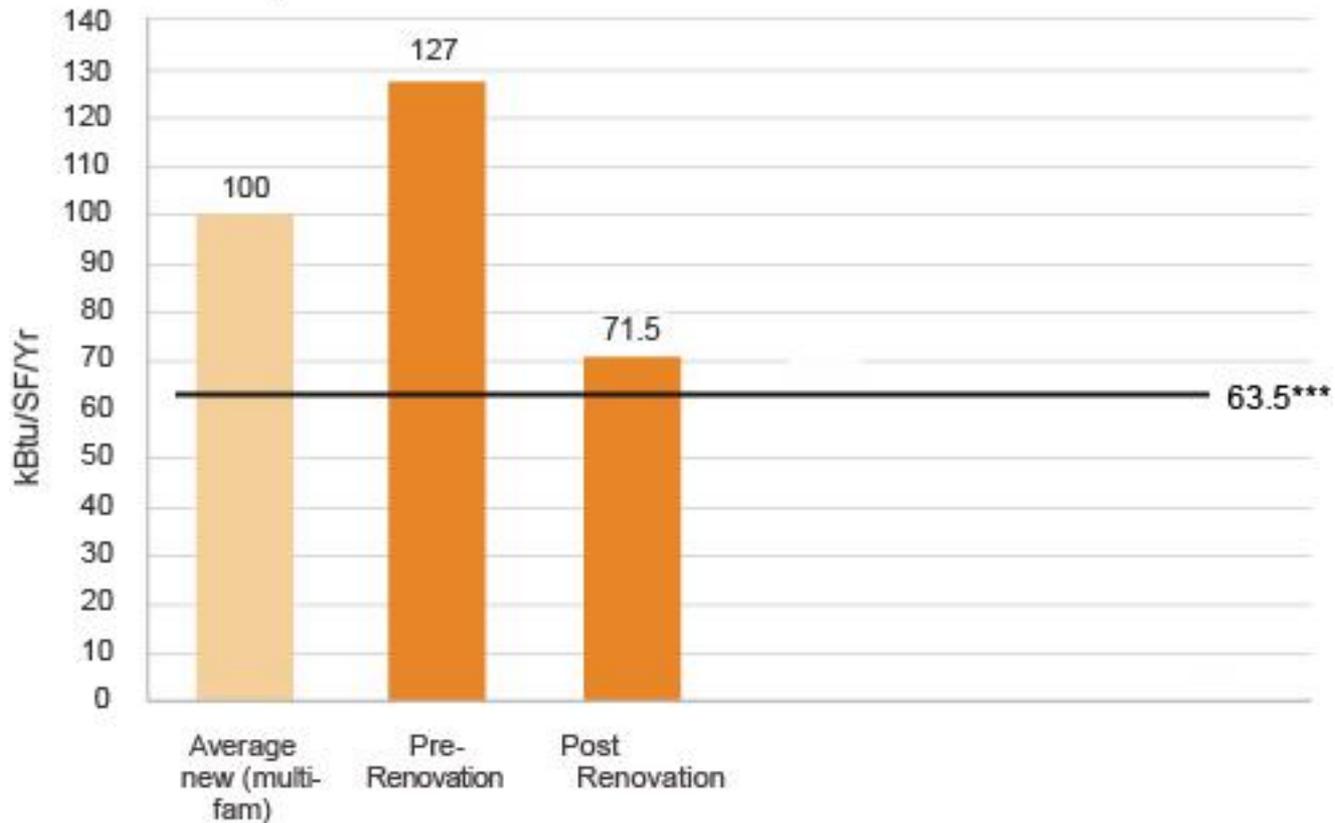
Annual Energy Intensity Ormess Plaza Apartments

**Average energy intensity (multi-family) - 100 kBtu/ sf-yr

Based on The Weidt Group multi-family housing modeling code estimate.

***MN 2030 Challenge Target for 2005-2009

44% reduction in energy use

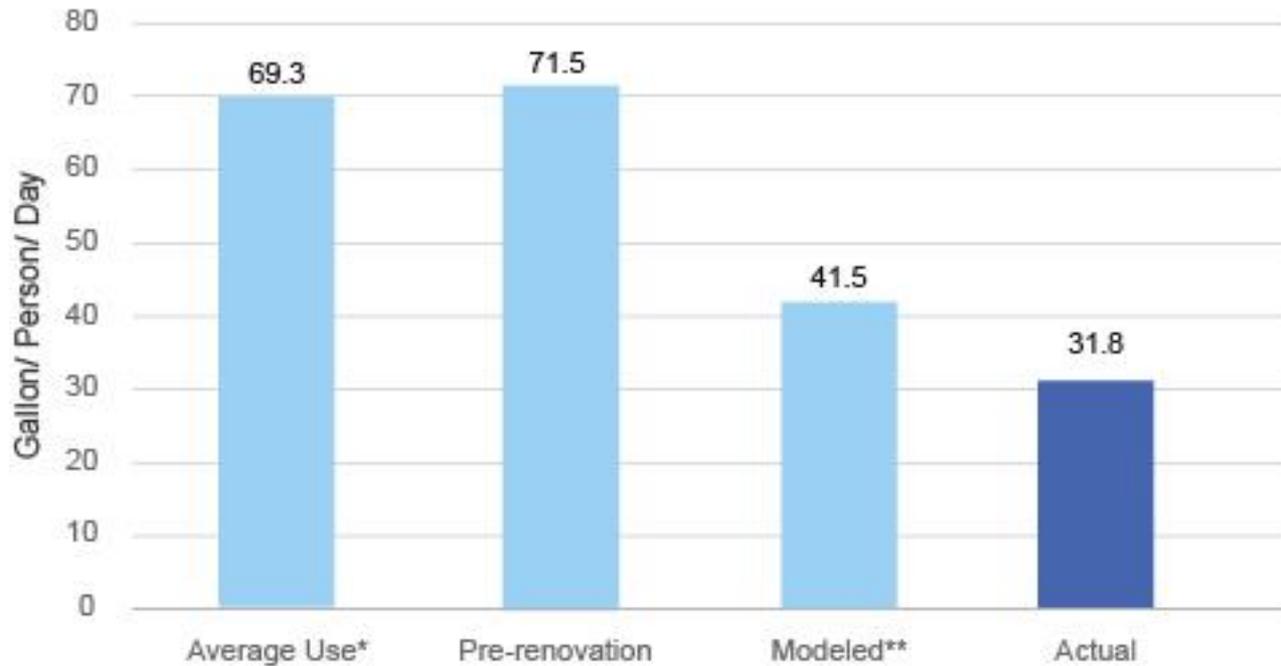
Indoor Water Use Omness Plaza Apartments

54% less water use per person
