LIQUIDARMOR™ CM Flashing and Sealant High Impact Technology Demonstration

December 2016

**LIQUIDARMOR™ CM Flashing and Sealant
High Impact Technology Demonstration**

Prepared by
OAK RIDGE NATIONAL LABORATORY
Oak Ridge, TN 37831-6283
managed by
UT-BATTELLE, LLC
for the
US DEPARTMENT OF ENERGY
under contract DE-AC05-00OR22725

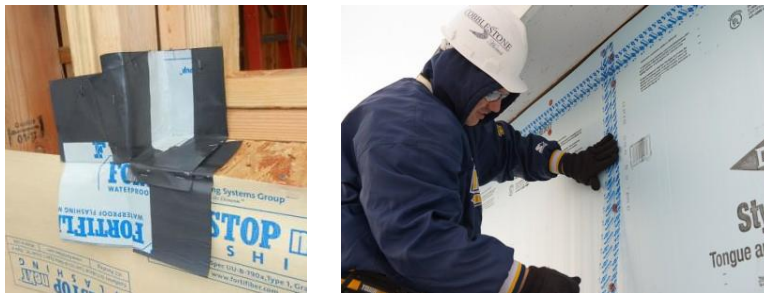
Figure 1. Tape used to flash window rough openings (left) and to seal joints between boards (right).

The effectiveness of an air barrier system relies on its continuity throughout the entire building envelope. Common areas where continuity is compromised are the wall-to-foundation and wall-to-roof joints, and gaps around items that penetrate the air barrier such as windows, doors, mechanical ducts, electrical outlets, and plumbing pipes. Air barrier systems include products that seal gaps and can also serve as flashing materials at window rough openings. Examples of these products are tapes (Figure 1), coatings with a reinforcing mesh (Figure 2), and liquid flashings (Figure 3). Main differences among these products are material cost, installation time, and installation cost. Furthermore, their performance will vary depending on the product's ease of installation and the amount of training and skill required for successful installations.

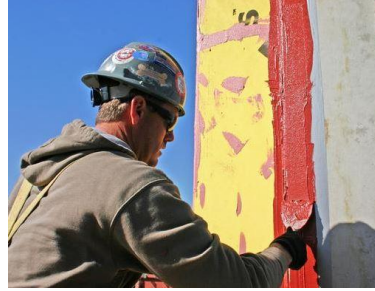
Figure 3. Liquid flashing applied with a caulk gun and trowel.

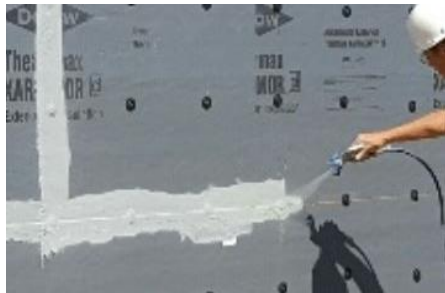
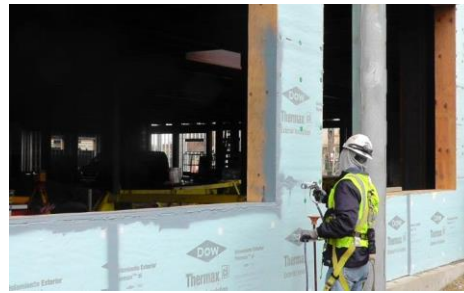
Figure 4. LIQUIDARMOR™ CM sprayed over board joints and a window rough opening.

LIQUIDARMOR™ CM Flashing and Sealant can span gaps that are up to a ¼ in. wide without the need for a supporting material (Figure 4) and can be installed with a regular airless paint sprayer making it faster to apply than tape, coatings that require a reinforcing mesh, and liquid flashings that are applied with a caulk gun and trowel.¹ Under the US-China Clean Energy Research Center for Building Energy Efficiency, ORNL assessed the performance of LIQUIDARMOR™ CM through laboratory evaluations per test standards from the American Society for Testing and Materials (ASTM) International^{2,3,4,5,6} and the American Architectural Manufacturers Association (AAMA).⁷ LIQUIDARMOR™ CM was installed in these evaluations over fiberglass mat gypsum sheathing and foil-faced polyiso foam boards, and gaps that were up to ¼ in. wide did not have a supporting material. These air barrier assemblies passed the aforementioned tests; that is, air leakage rates were less than 0.04 cfm/ft² at 1.57 psf per the 2015 International Energy Conservation Code (IECC) requirement for air barrier assemblies and water penetration was not observed throughout the tests (Hun 2016).

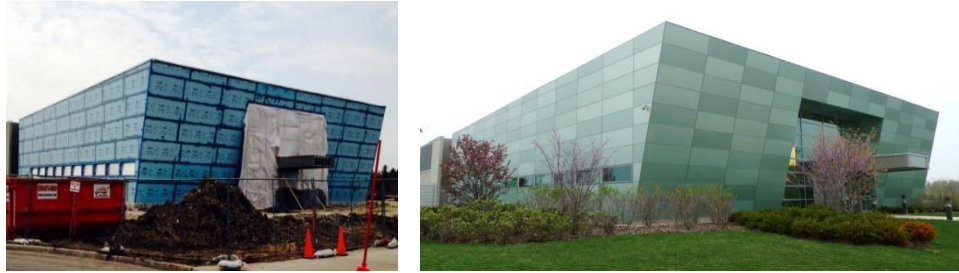
Figure 5. Front of the Homeland Security Training Center. The picture on the left shows exterior insulation that was sealed at its joints with LIQUIDARMOR™ CM Flashing and Sealant. The picture on the right shows the finished building clad with metal curtainwall panels.

The Homeland Security Training Center (HTC) at the College of DuPage served as a demonstration site for third party verification of LIQUIDARMOR™ CM Flashing and Sealant performance. HTC is located in Glen Ellyn, IL, was built to comply with the 2009 IECC, and was completed in the fall of 2015. This building has an area of 34,600 ft² on its first floor and 6,000 ft² at its basement/mechanical room. The front third of the building is primarily composed of classrooms and the back of the building is used as an enclosed and air conditioned shooting range. In the front third of the building, the air barrier system is composed of continuous exterior insulation that is sealed at its joints and gaps with closed-cell spray foam from the inside of the building and LIQUIDARMOR™ CM from the exterior side (Figure 5). As illustrated in Figure 6, the air barrier system in the back of the building is made of insulated precast concrete panels in which joints were treated with backer rods and sealants that are typically used with precast concrete.

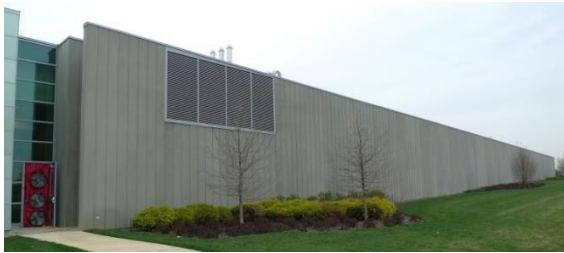
Figure 6. Back of the Homeland Security Training Center. Exterior walls are made of insulated precast concrete panels.

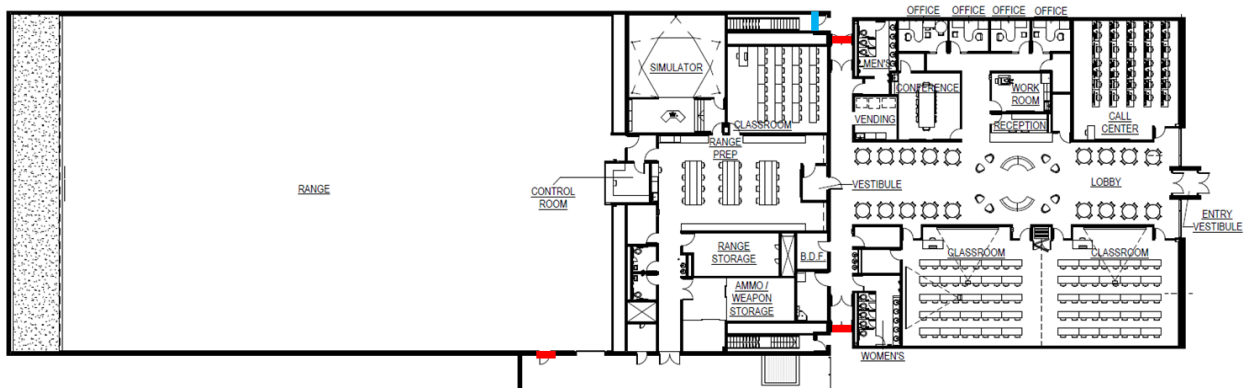
Figure 7. Location of blower door fans. The red lines indicate a group of three fans that were used to pressurize/depressurize the first floor. The blue line shows the location of three fans that guarded or isolated the basement.⁹

ORNL hired TMI[®] as a contractor to measure the air leakage rate of the HTC. On April 30, 2016, TMI[®] conducted a blower door test per ASTM E779-10.⁸ The basement was isolated or guarded because of its negligible contribution to air leakage given that this space is below grade. Twelve fans were used as shown in Figures 7 and 8; nine pressurized/depressurized the first floor and three guarded the basement. Louvers that provide fresh air (Figure 8) were closed with mechanical dampers. Equipment setup, air leakage measurements, and equipment dismantling were completed in 10 hours.

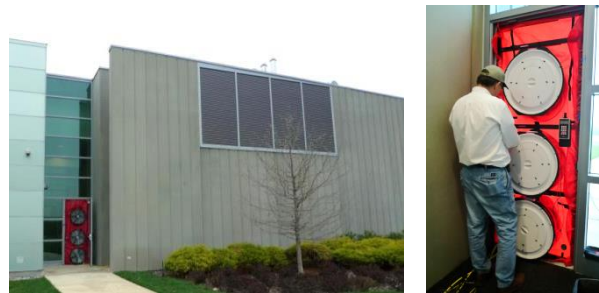
Figure 8. Blower door setup on west side of building. Left picture shows the louvers that provide fresh air and that were closed with mechanical dampers during the blower door test.

louvers. Therefore, the measured air leakage rates are likely higher than the actual leakage rates because the HTC louvers were closed with dampers during the blower door test.

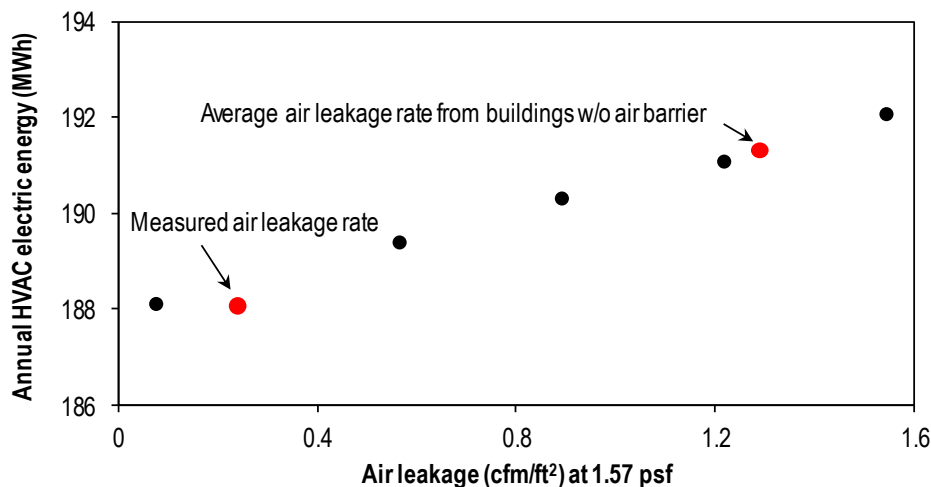
Figure 9. Simulation results of the annual HVAC electric energy consumed by the Homeland Security Training Center as a function of air leakage rate through the above grade walls and roof.

Figure 9 illustrates the simulation results for the annual cooling energy consumption as a function of air leakage rate and suggests that the airtightness level of the HTC can lead to an energy usage of about 188 MWh per year. Furthermore, Figure 9 suggests that the higher leakage rate from buildings without an air barrier could increase the cooling energy use of the HTC to 191 MWh; this change is minor because of the relatively mild summers at DuPage, IL, in which the average high temperature in July is 81°F. Conversely, Figure 10 shows that the annual heating energy increased by 26% because consumption grew from 950 MBtu to 1,200 MBtu given that the winter season is more severe than the summer.

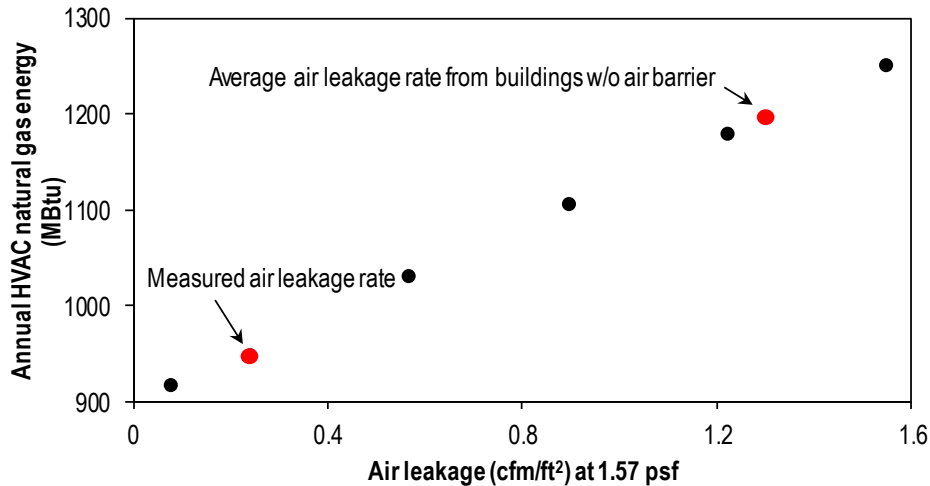
Figure 10. Simulation results of the annual HVAC natural gas energy consumed by the Homeland Security Training Center as a function of air leakage rate through the above grade walls and roof.

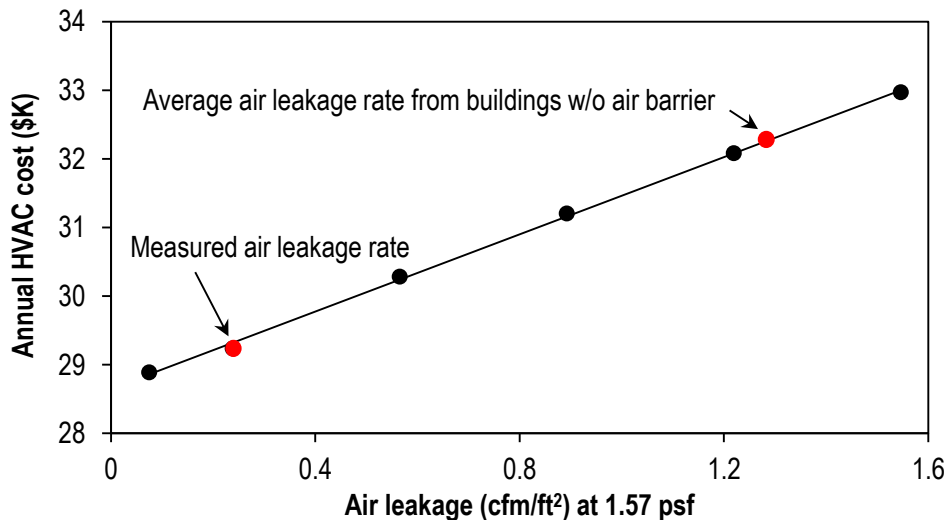
Figure 11. Simulation results of the annual HVAC energy cost for the Homeland Security Training Center as a function of air leakage rate through the above grade walls and roof.

Figure 11 translates energy use to cost by assuming rates of \$0.1 per KWh for electricity and \$11.1 per MBtu for natural gas. Results indicate that by having an airtight envelope the HTC saves about \$3,000 per year than if it lacked an air barrier system. These savings could be higher because the measured leakage rate was likely greater than the actual value given the imperfect sealing of the large louvers by the mechanical dampers during the blower door test. Nevertheless, it should be taken into account that this estimate is highly dependent on numerous variables, such as the location of the building, building envelope materials, the type and efficiency of the HVAC system, HVAC heating and cooling set point temperatures, lighting and internal loads, HVAC operational schedule, occupancy schedule, and type of fuel used by the HVAC system.
